# **SERVICE BULLETIN**

PRODUCT: Plasmavision

MODEL: H2 panel models

SUBJECT: Electric components modification

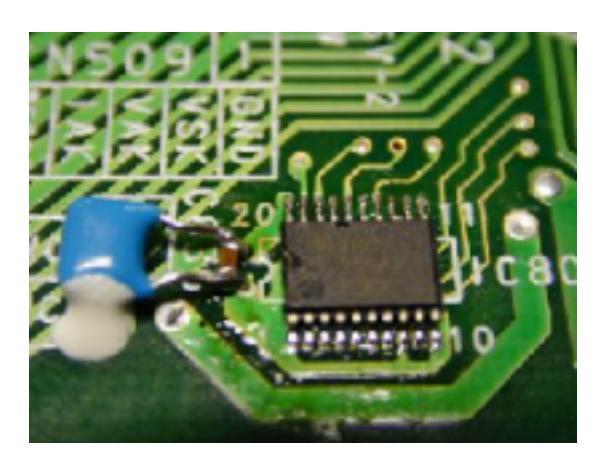
The noise does overlay to the VCC power supply of IC804 and it damages IC804. IC142 is destroyed due to the solder crack of the chip resistor.

1.Main Power PCB is removed.

- 2. The capacitor with the lead is added to C836(chip capacitor) of the Main Power PCB.
- \* If IC804 has been damaged, exchanges for new IC.

It confirms whether soldering capacitor and IC is correct.

Shorten the Condenser foot as much as possible.
