# **SERVICE BULLETIN**

PRODUCT: Plasmavision

MODEL: H2 panel models

SUBJECT: Electric components modification

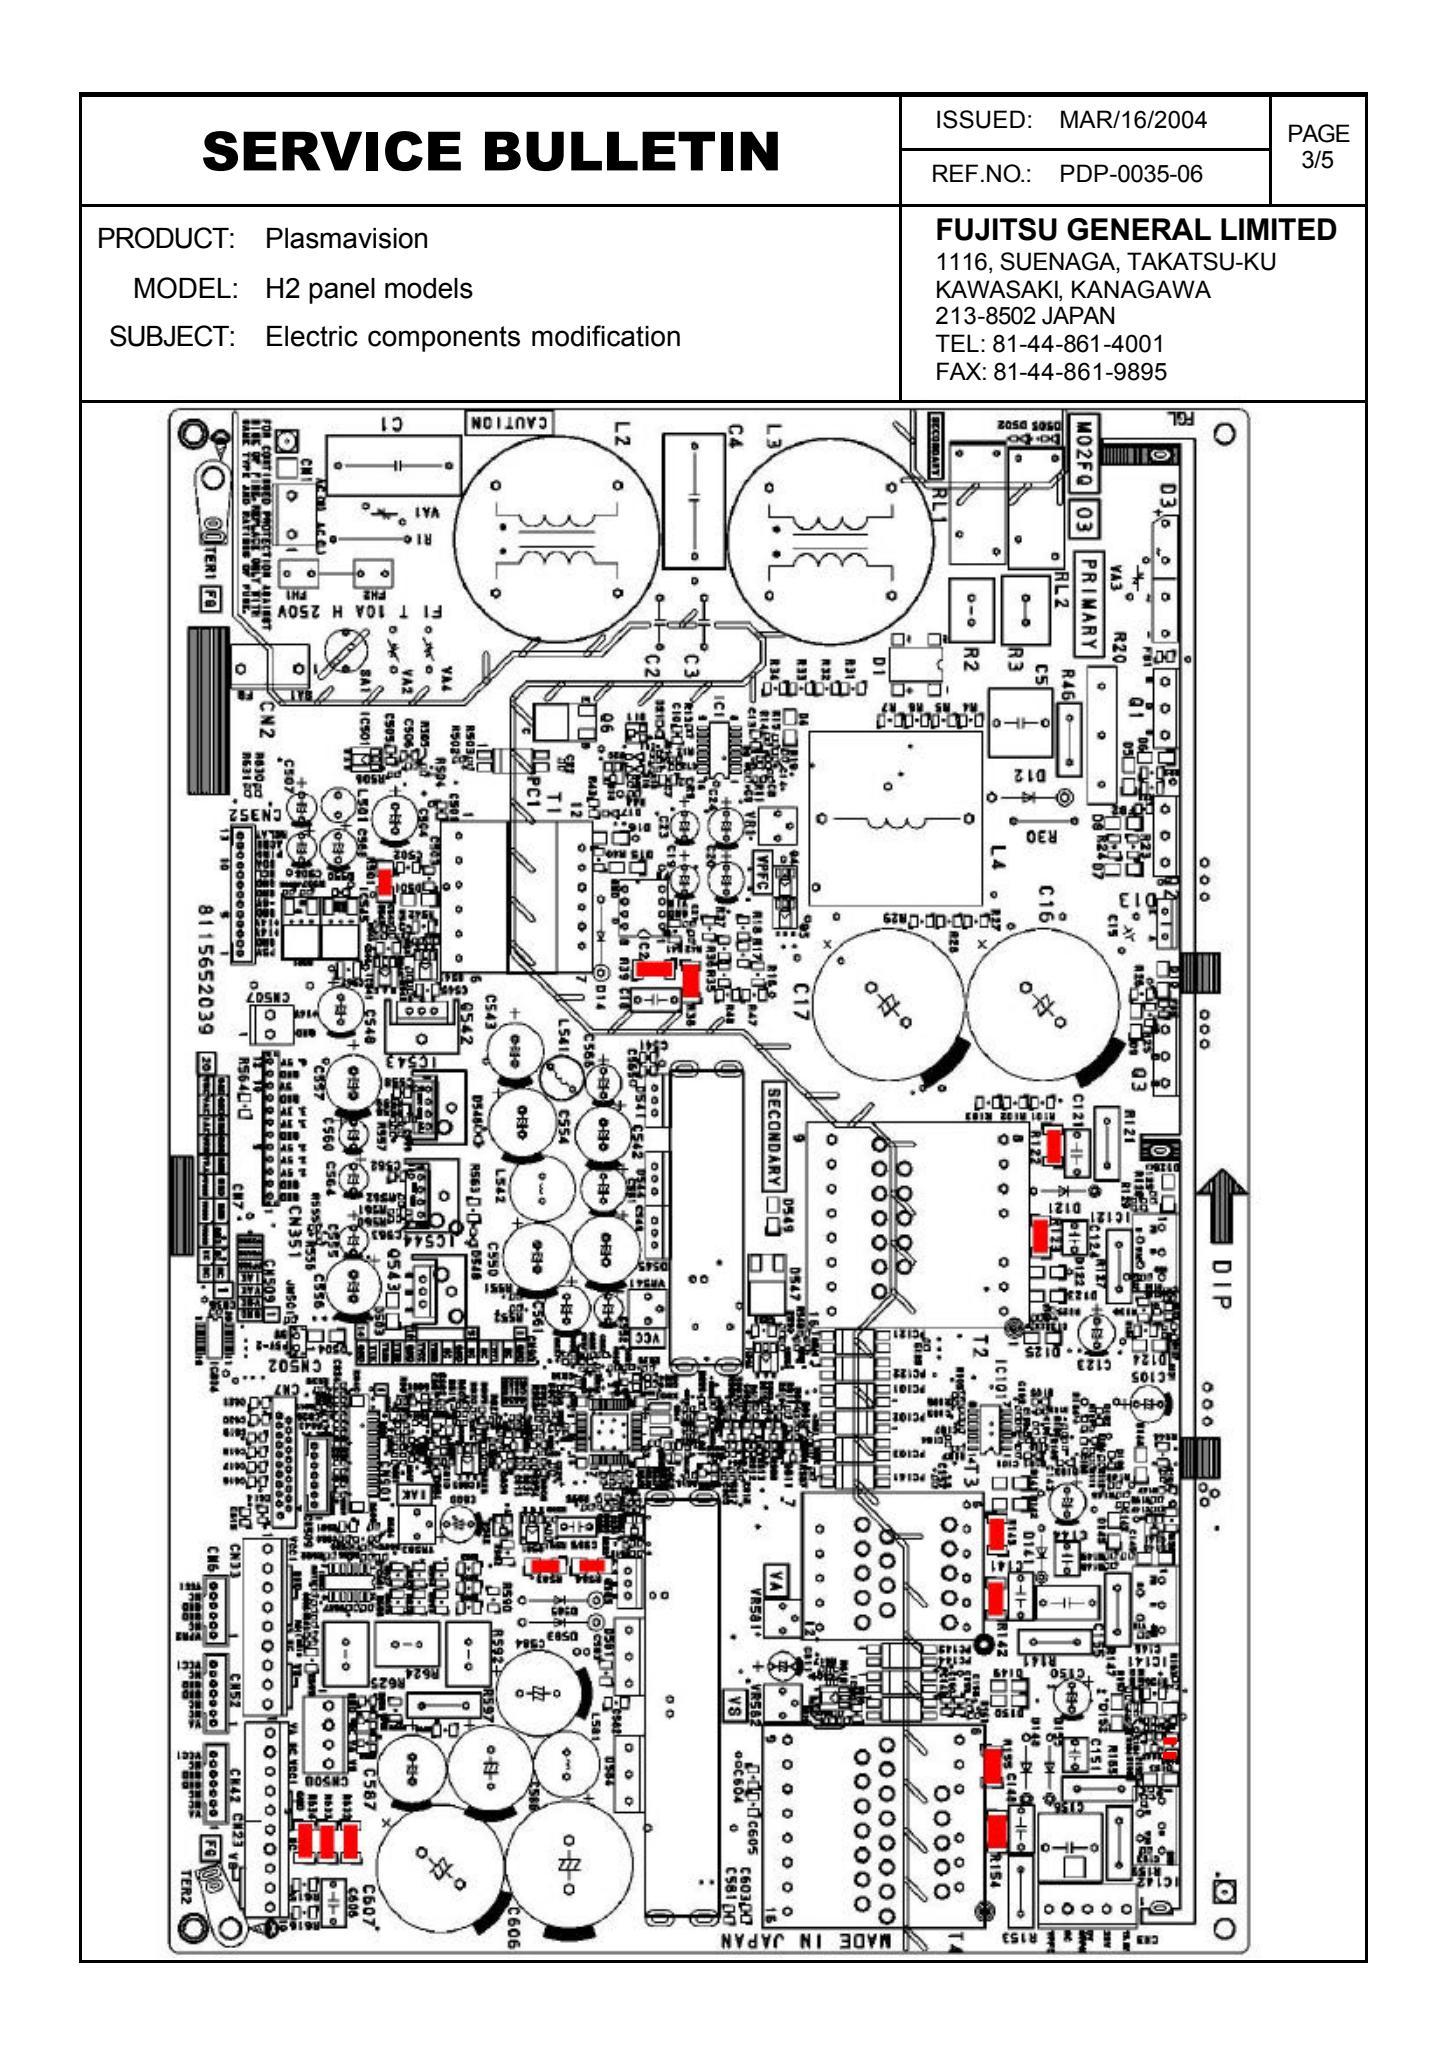
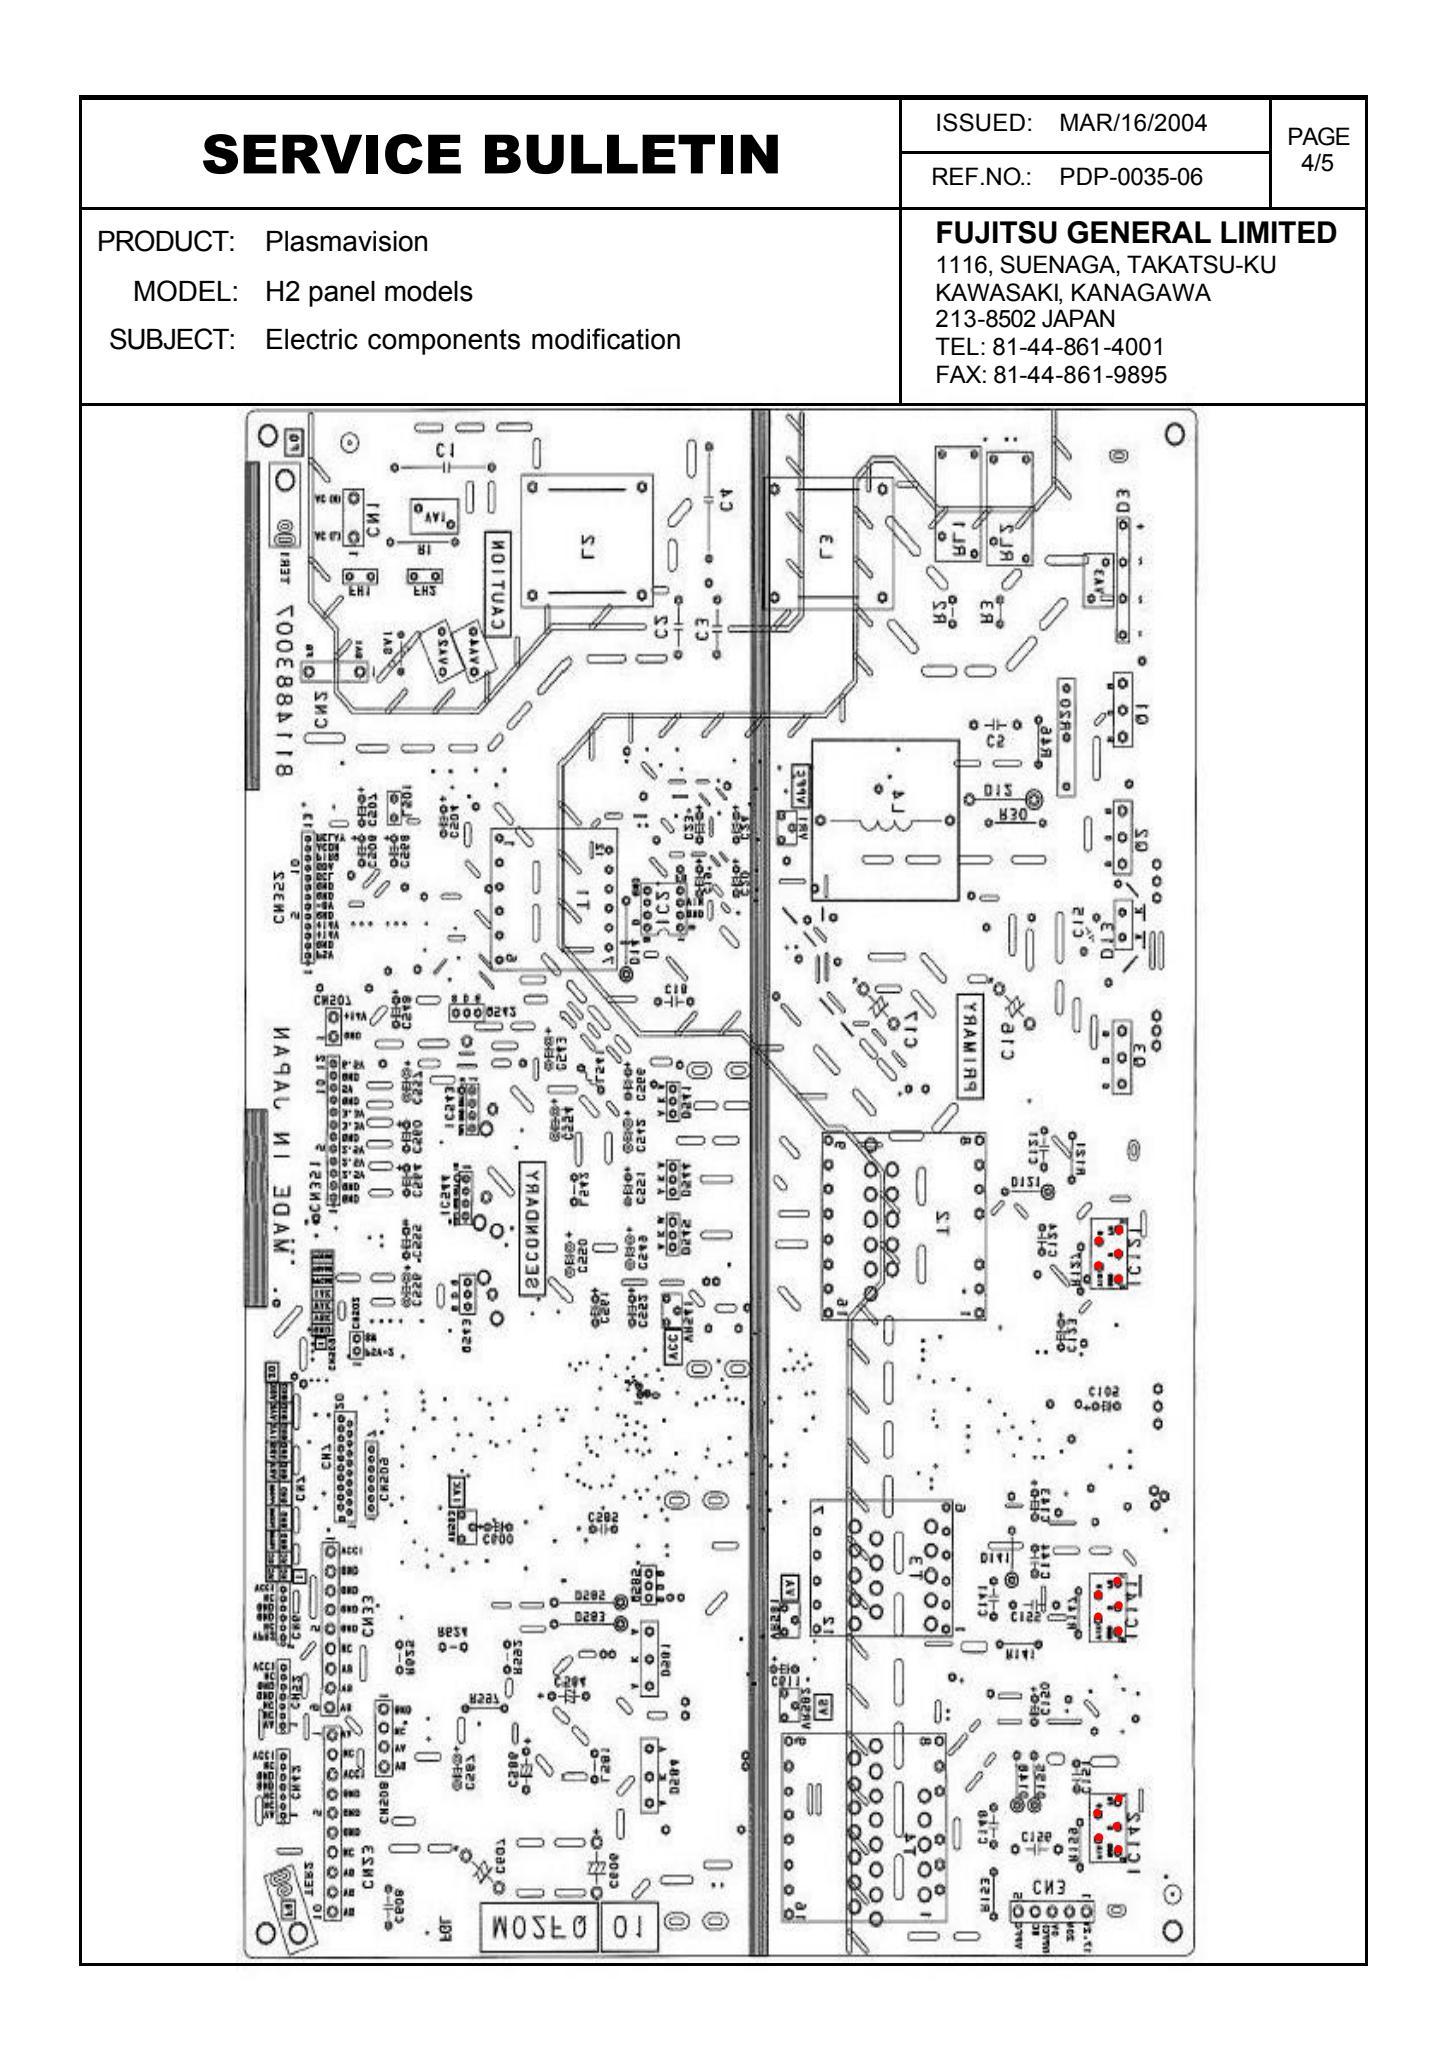
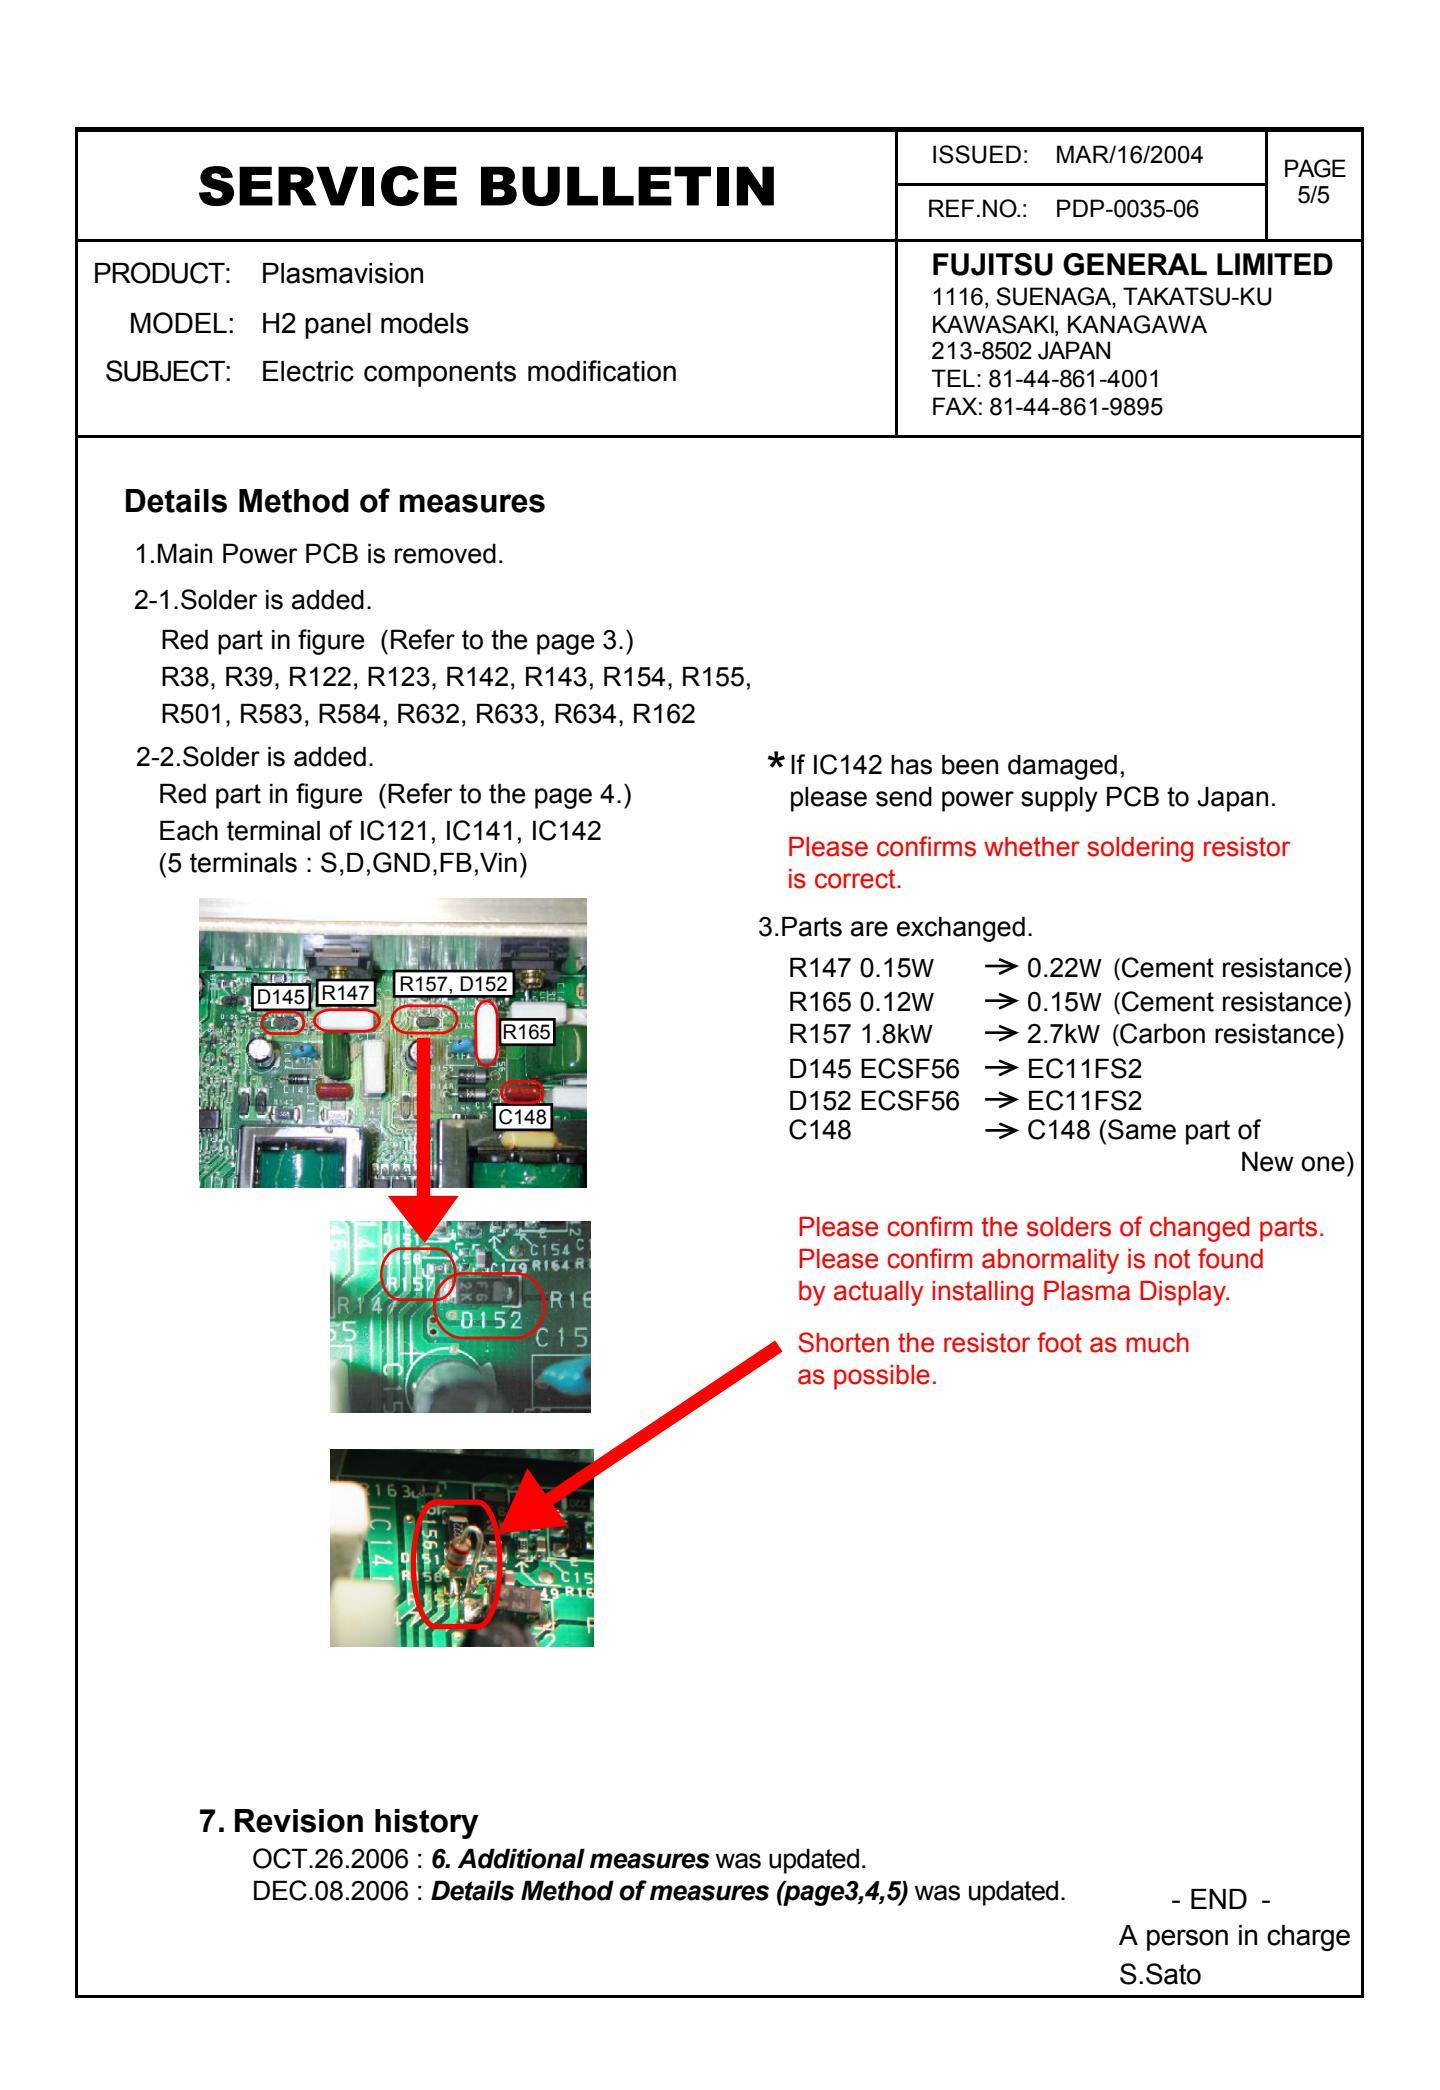
IC804 of Main Power PCB IC142 of Main Power PCB Resistor (1W, 1/2W, 1/4W) solder crack of Main Power PCB

The noise does overlay to the VCC power supply of IC804 and it damages IC804. IC142 is destroyed due to the solder crack of the chip resistor.

The capacitor with the lead is added to C836 of Main Power PCB.

- Preventive maintenance Solder is added.
  R38, R39, R122, R123, R142, R143, R154, R155, R501, R583
  R584, R632, R633, R634, R162
  Each terminal of IC121, IC141, IC142
- 3. A case of LED lamp blinking

- 2. The capacitor with the lead is added to C836(chip capacitor) of the Main Power PCB.
- \* If IC804 has been damaged, exchanges for new IC.
